Notre-Dame Cathedral Fire

Michaela Ďurčíková^{1, *}, Zuzana Vidholdová¹

Short report

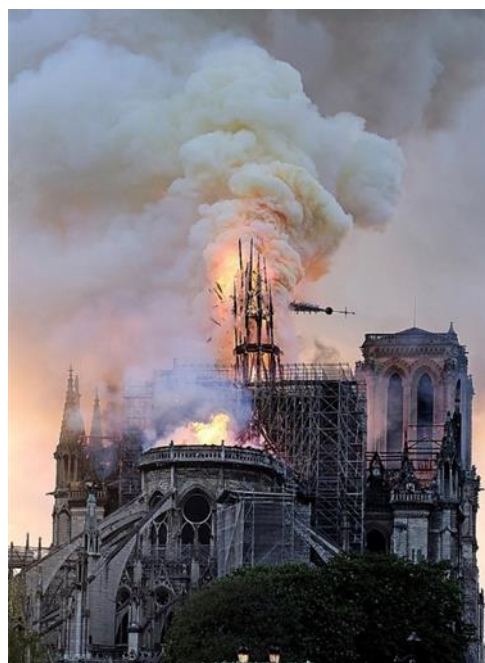
The fire, which lasted 15 hours, destroyed the tower of the building, the roof of the entire ship, the upper parts of the walls, medieval stained-glass windows, and part of the interior. However, the cause of its occurrence has not yet been precisely determined. It is assumed that the fire originated from a cigarette or electrical short circuit during reconstruction work. But there is no indication that this was intent or arson.

Fig 4. Collapse of the Sanctuary tower

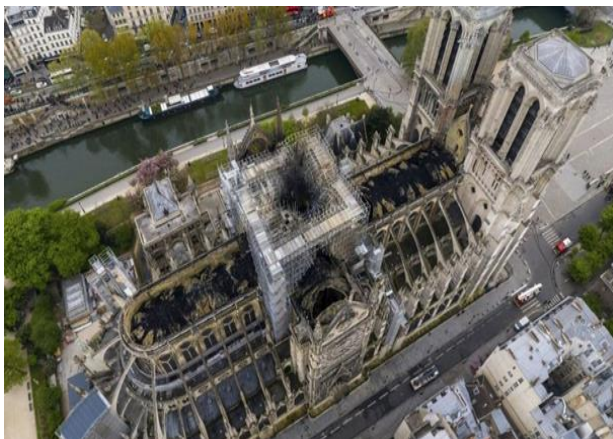
The Gothic cathedral is like a house of carats: - if one side weakens, the whole side will collapse. Due to its bold height and the fact that the outer walls are weakened by several layers of windows, its structure is fragile. For months, no one could enter the cathedral due to the danger of lead dust and debris falling from the broken vault. A lone robot, controlled by a remote control, was able to clean up the burnt remains.

Fig 5. Notre-Dame Cathedral after fire

The first phase of restoration - conservation and protection - lasted 15 months. President Macron has appointed General Jean Louis Georgelin, the former head of President Sarkozy's office, to oversee the work. Under the 28 pillars, wooden supporting vaults are placed, which, however, are not fixed in the stone (Fig. 6). Each of the beams had different dimensions, and therefore its mounting required maximum accuracy.

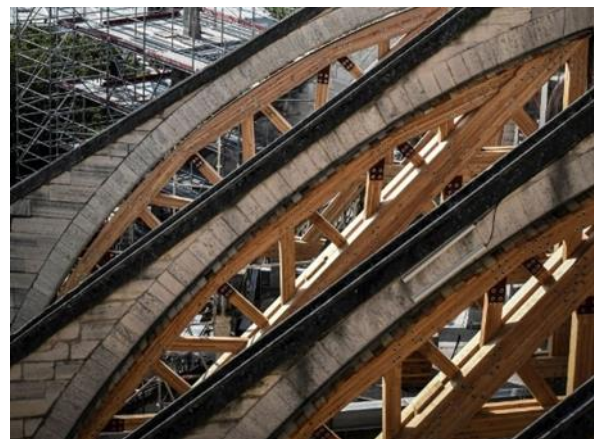
Fig 6. Wooden support vaults

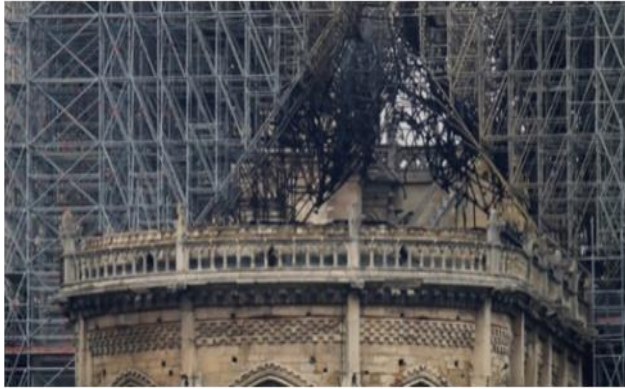
Then began the most difficult and dangerous operation: the dismantling of the scaffolding, which was built in May 2018 to repair the crumbling tower (Fig. 7). This scaffold melted to form an ugly and ill-looking black mass of 40,000 metal pieces glued together. Workers with a rope approach (Fig. 8) (called cordists in French) had to collect the pieces by hand one by one, hanging on ropes high in the air. Sensors were placed under this unstable mass.

Fig 7. Wrenched scaffolding

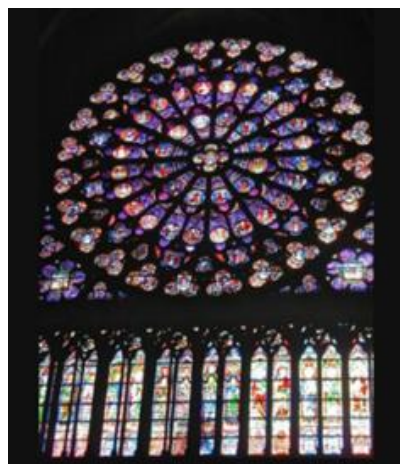
Some works of the cathedral were saved due to reconstructions (from fire). For example, 16 copper statues representing the twelve apostles and four evangelists to cleanse and restore them. The rooster that was on top of the tower is now on display in the Archaeological Museum and will remain there as well. He will be replaced by a replica. Fortunately, the organ and the three pink windows have been preserved, but they will require a lengthy renovation. It is particularly gratifying to know that the rose window at the southern end of the transept is intact (Fig. 9) (Logan, 2021).

Fig 9. Pink Window at South End Transept

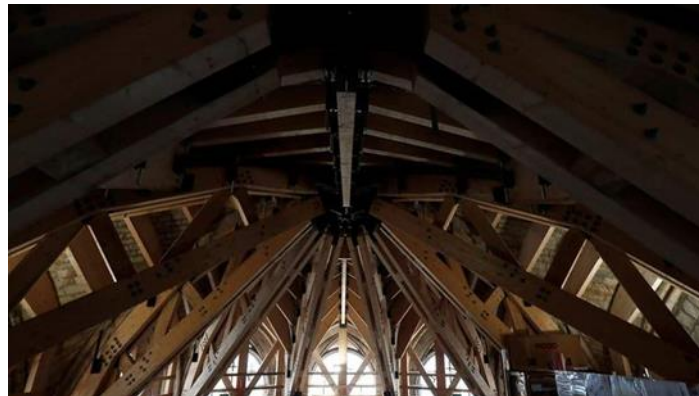
Fig 13. Wooden beams supporting vault

At present - two years after the fire (April 15, 2021), the process of restoring the Notre Dame Cathedral is being strengthened by strengthening the vault of the cathedral and preparing a future wooden structure that will support the roof. It should be ready by next summer. Most of the interior of the cathedral is now filled with metal scaffolding. To protect against the rain, an umbrella sail was installed above the through hole, where the tower once stood. The stone, metal, glass in the interior have already been cleaned. Wooden scaffolding is still being installed to stabilize the fragile areas of the cathedral vault, as well as the vaults. Stonemasons fill in the gaps and missing stones in the perimeter walls. They reinforce the most damaged areas with glass fibers.

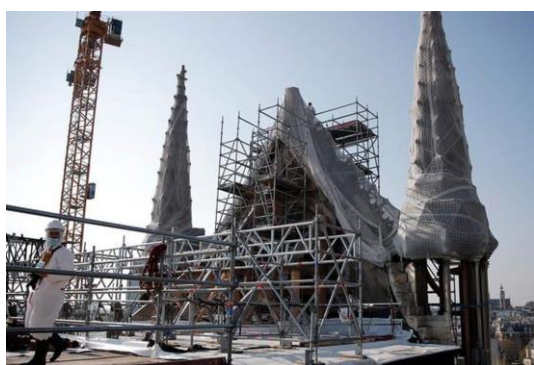
Fig 14. Current reconstruction work

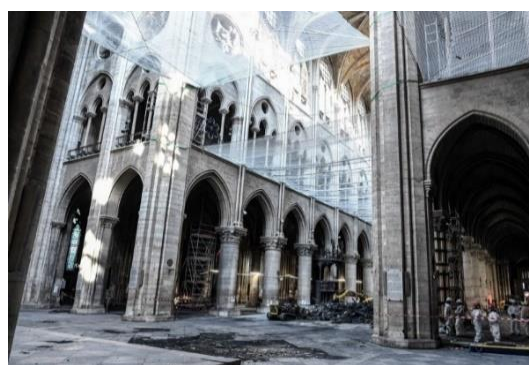
Fig 15. Reconstruction work indoors
