Libušín – Historical Building Fire

Case Study

Abstract

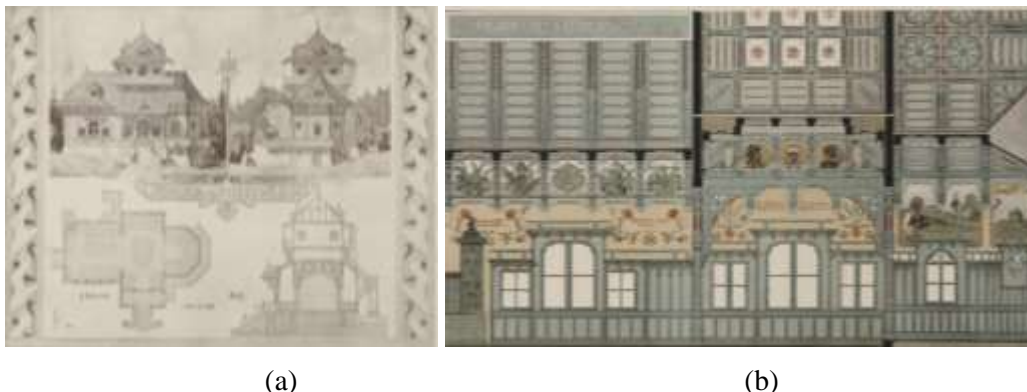
The Libušín (Fig. 1) was built as a wooden log construction in the style of Folk Art Nouveau with a rich decor, which is typical for folk buildings in individual areas of Moravian Wallachia and Slovakia. The building had a stylish restaurant dining room with a capacity of 200 guests, which was built in the years 1897-1899 and named in honor of the Princess Libuše. There was also a kitchen, including food warehouses and facilities for staff, sanitary facilities for guests and a bar. The original building was followed by a separate technical background, which had brick perimeter walls with wooden cladding. The most valuable part of the dining room was the hall with richly decorated frescoes and sgraffitoes. They depicted motifs of Wallachian and Slavic legends, designed by the artist Mikoláš Aleš and painted by Karel Štapfer. An apartment was set up in the attic above the hall on the second floor, which in the time before the fire only served to store unused equipment. Above it was a lookout tower. The interior of the dining room was designed by the architect Jurkovič himself and consisted of three chandeliers, a sideboard, a greenhouse, a clock and 100 carved chairs (Hasalík, 2009).

Fig. 1 (a) Original designs of Libušín, (b) Libušín's interior decoration (Jurkovič 1900).

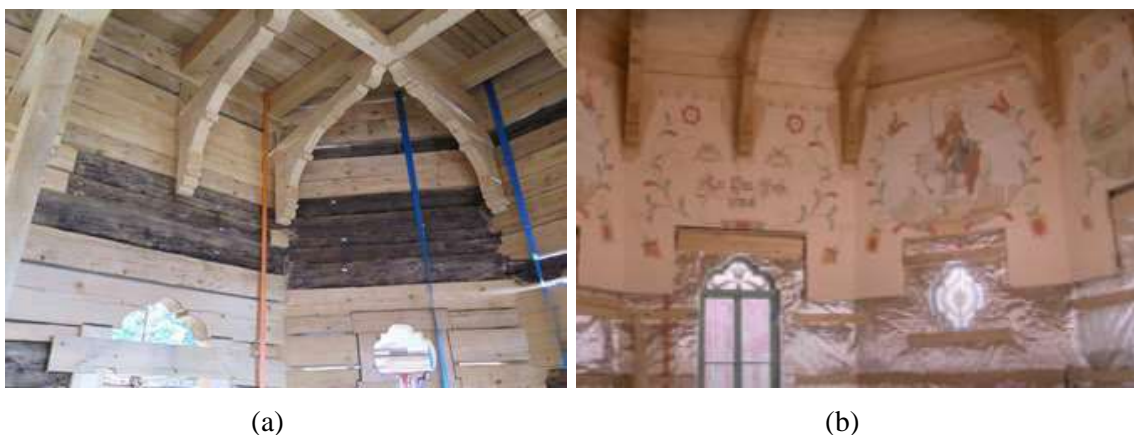
During the construction of the new Libušín, traditional woodcraft techniques were followed, and the original materials and technologies were used (Bryol et al., 2020; Kloiber, 2020). One of them is that timber must be logging in the winter during the latent period, when there is a minimum of water and tissue in the tree trunk. This contributes to increasing resistance to wood durability. Therefore, the logging was in winter after a full month from November 2016. All wooden components in wet state were hand-worked, as was done at the time of the original construction. Hand-worked wood was used for the dining room building, the surface of which is smoothed by planing and not sanded. It affects not only the appearance of the surface but also its quality. In accordance with dendrological purposes, fir wood was used for parts of the dining room and spruce wood for other parts. The threshold beams in contact with the foundations were made of oak wood. The external staircase was made of spruce wood and the decorative elements in the windows were made of aspen wood (Prudík, 2019). Surface charred original wooden elements had to be cleaned to sound wood and their state was either used on its original place, or as material for another suitable place (Fig. 2a).

Fig. 2 (a) Log cabin wall with built-in original beams (Novák, 2018); (b) Paintings and frescoes in the new dining room, the vapour barrier is also visible in the lower part (Masák & Partner s.r.o., 2021).

An important feature of Jurkovič's buildings is the color of the exterior cladding and interiors. Restoration surveys, laboratory analyses, photo surveys and, in close collaboration with conservationists and conservators, identified and selected nine color shades for surface coating of exterior elements such as perimeter cladding, brackets, railings, columns and for painting plant parts and geometric elements. Seven shades of the top color and three types of underpainting were identified, which were then applied in the interior. The color of Libušín returned to 1899. A manufacturer with a corresponding recipe for oil paints was found at Ottoson in Sweden (Matulíková et al., 2014; Dvořák, 2019). The interior decoration of the dining room, painting the walls with frescoes and sgraffitoes, was successfully restored to its original condition (Fig. 2b). According to the preserved drawings of the artist Mikoláš Aleš, their contemporary artists reproduced them.
