Notre-Dame Cathedral Fire

Michaela Ďurčíková^{1, *}, Zuzana Vidholdová¹

Short report

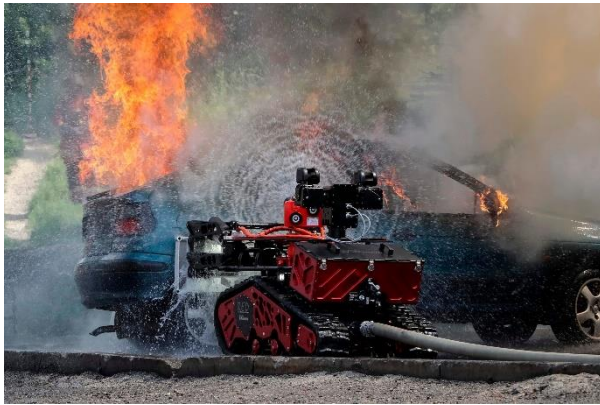
At 6:43 p.m. the alarm was activated again. The fire started in wooden beams under the roof, which is also nicknamed the forest. At that time there was a mass in the cathedral, people were subsequently evacuated. The fire then spread quickly. The temperature also reached 800 degrees Celsius and was fought by more than 400 firefighters. The fire was primarily fought from inside the structure, which was more dangerous for the staff, but reduced the potential damage to the cathedral, applying water from the outside risks draining flames and hot gases (at temperatures up to 800 ° C) to the inside. Flood cannons were used at lower than usual pressures to minimize damage to the cathedral and its contents. Aerial firefighting was not used because water falling from heights could cause structural damage and heated stone could crack when suddenly cooled. Helicopters were not used due to dangerous rising currents, but drones were used for visual and thermal imaging and robots for visual imaging and directing watercourses (Fig. 2). Molten lead falling from the roof posed a particular danger to firefighters.

Fig 2. Robot for visual display and guidance of watercourses

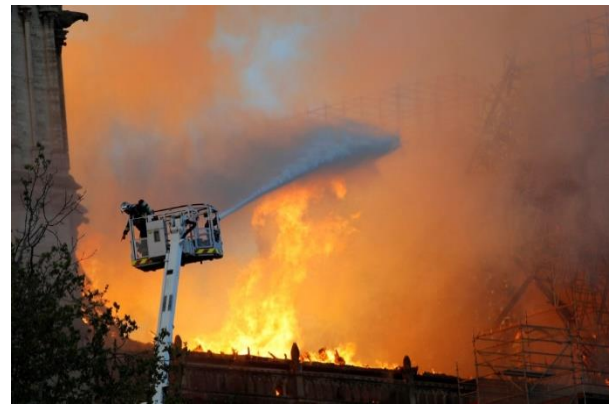
Fig 3. Fire extinguishing from platform

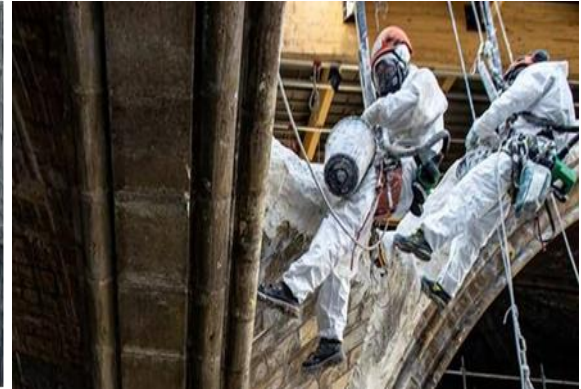
Then began the most difficult and dangerous operation: the dismantling of the scaffolding, which was built in May 2018 to repair the crumbling tower (Fig. 7). This scaffold melted to form an ugly and ill-looking black mass of 40,000 metal pieces glued together. Workers with a rope approach (Fig. 8) (called cordists in French) had to collect the pieces by hand one by one, hanging on ropes high in the air. Sensors were placed under this unstable mass.

Fig 8. Rappelling workers in protective suits
